# FORM B – BUILDING

**Town:** Reading

**Address:** 1149 Main Street

**Historic Name:** Haggerty-Schneider House

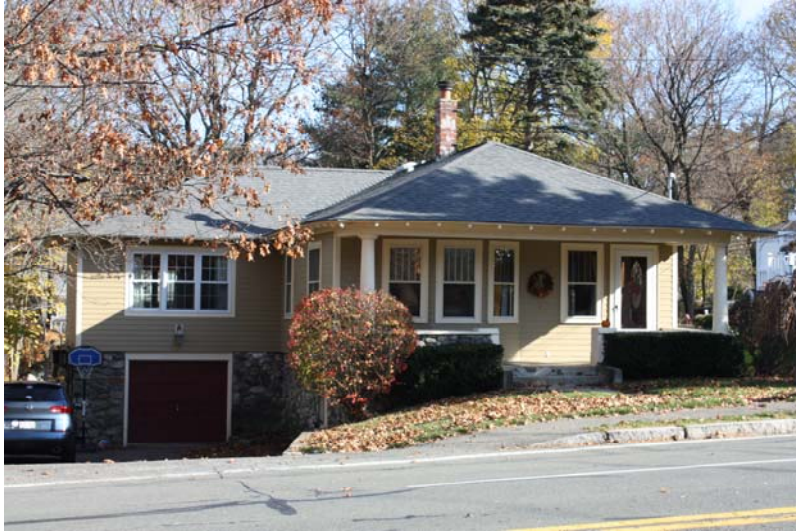
## Photograph

**Condition:** good

The house at 1149 Main Street is a variation on the early 20<sup>th</sup> century Bungalow style. The single-story structure is set on a rubble foundation and capped by a hip roof which extends to shelter a recessed porch on the façade. The overhang is supported by Doric columns which rest on a rubble half wall. The overhanging eaves are trimmed with exposed rafter tails. Underneath the porch, the sidehall entry contains an original wooden door with oval glass. The windows adjacent to the entrance including an individual unit and a three-sided bay window, all display a double-hung sash with five vertical panes in the upper sash above a single light lower sash.

Attached to the north of the main house is a hip-roofed section with a single garage opening on the lower (rubble) level. Above the garage door is a set of three 6/6 windows.
