Notice of Intent

Birch Meadow Park Phase 1

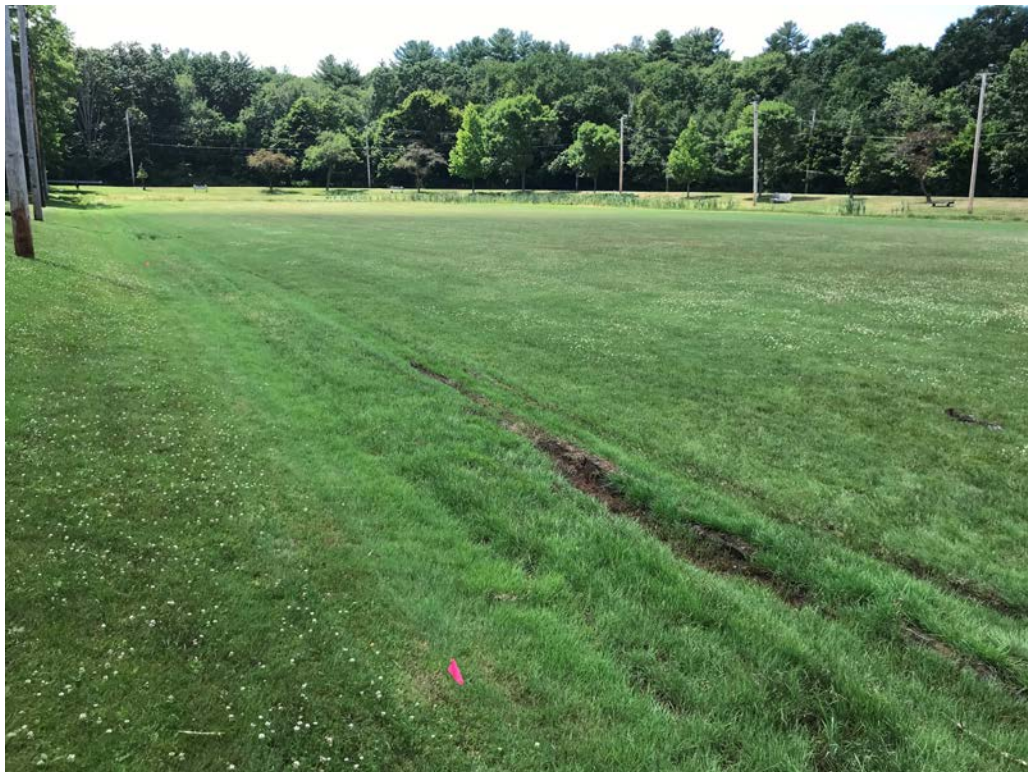
Photo 8: View northwest from southern perimeter of the field. Lawn mower tire ruts were observed within the southern perimeter swale.

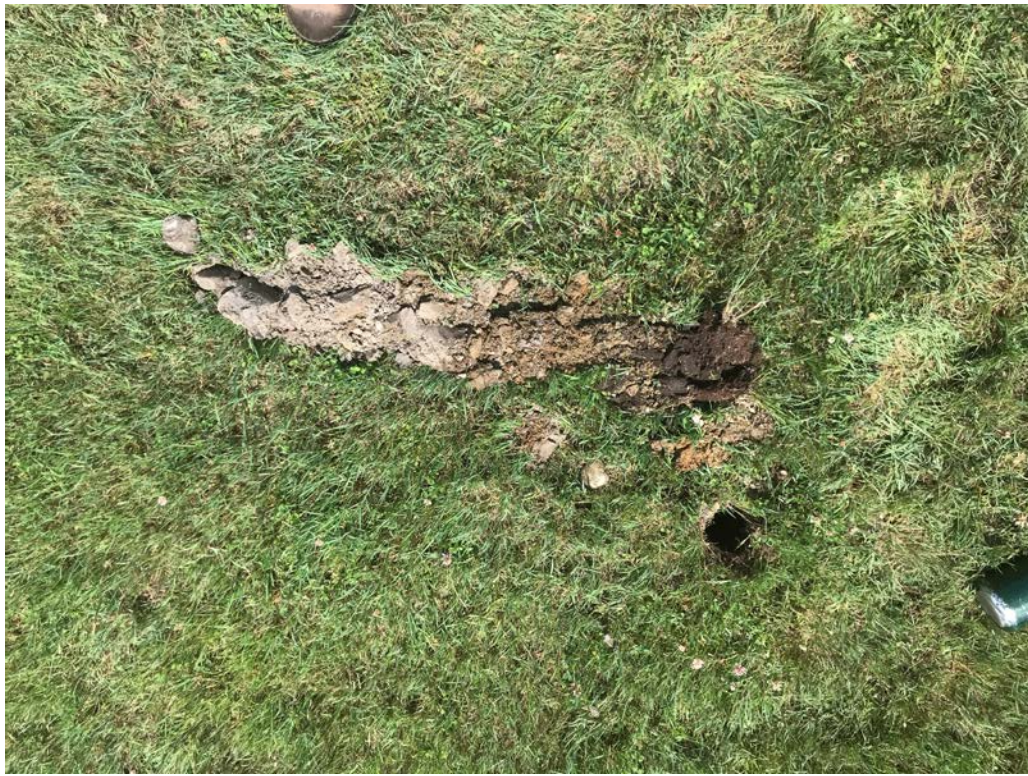
Photo 9: View of soil profile from augured observation pit #1. This pit was located along the south central perimeter of the field. Hydric soil indicators were observed within 12" of the soil surface and the water table was measured at 13" below the soil surface.

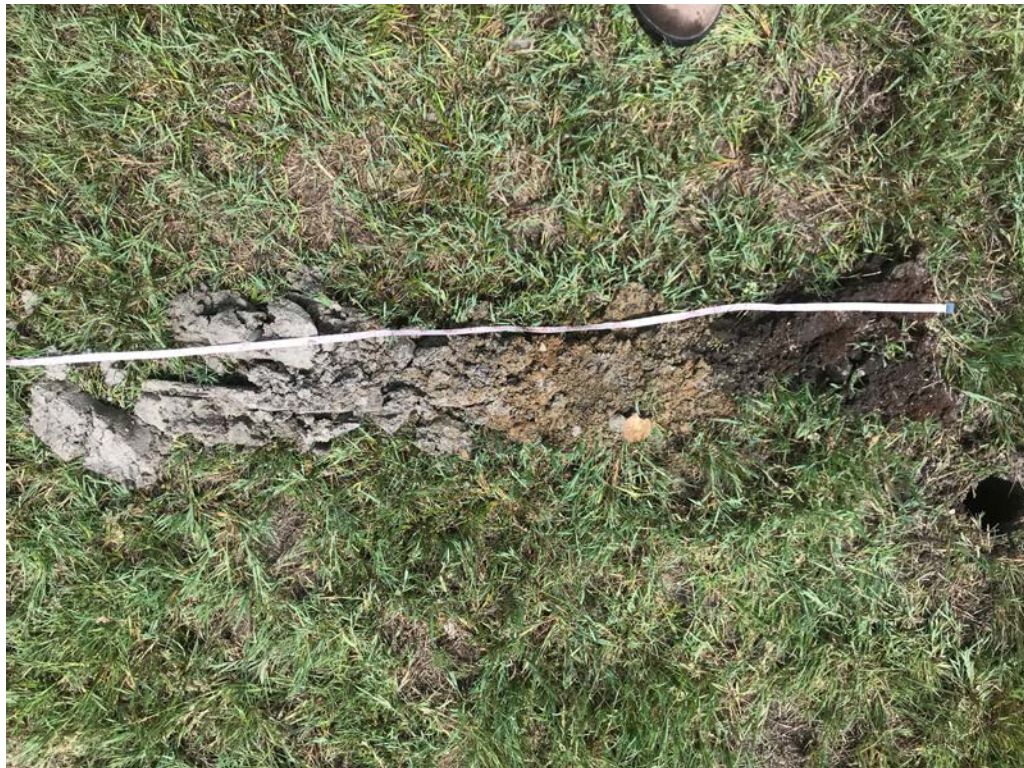
Photo 10: View of soil profile from augured observation pit #2. This pit was located towards the center of the field. Hydric soil indicators were observed within 12" of the soil surface and the water table was measured at 16" below the soil surface.

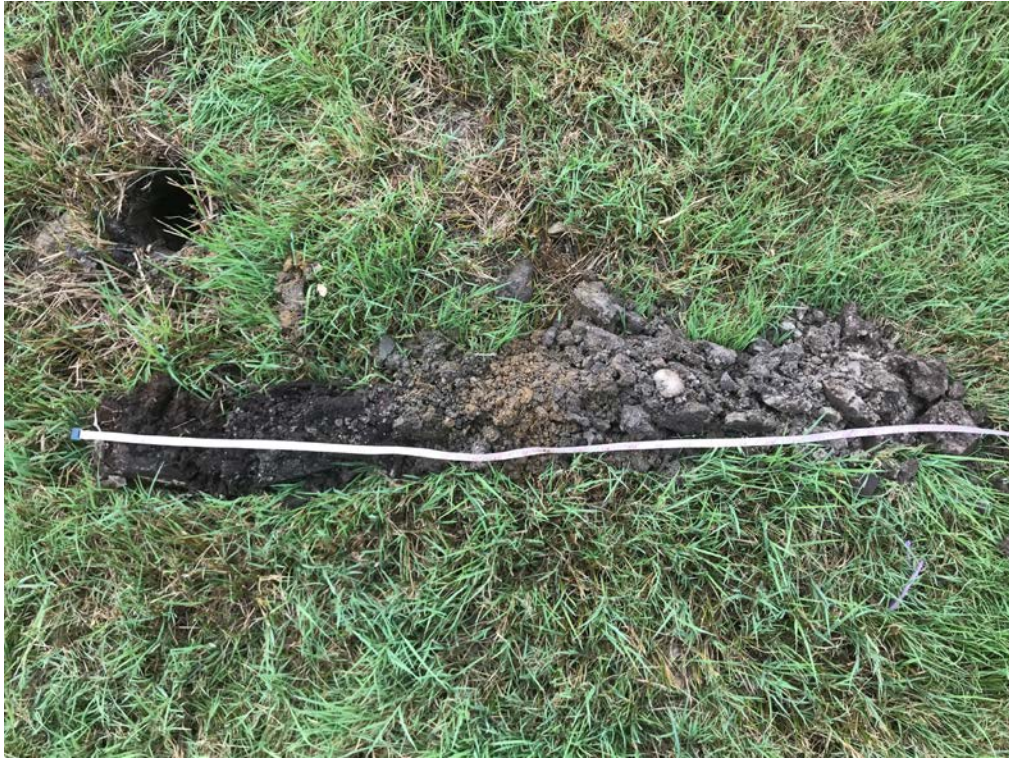
Photo 11: View of soil profile from augured observation pit #3. This pit was located towards the center of the field. Hydric soil indicators were observed within 12" of the soil surface and the water table was measured at 14" below the soil surface.

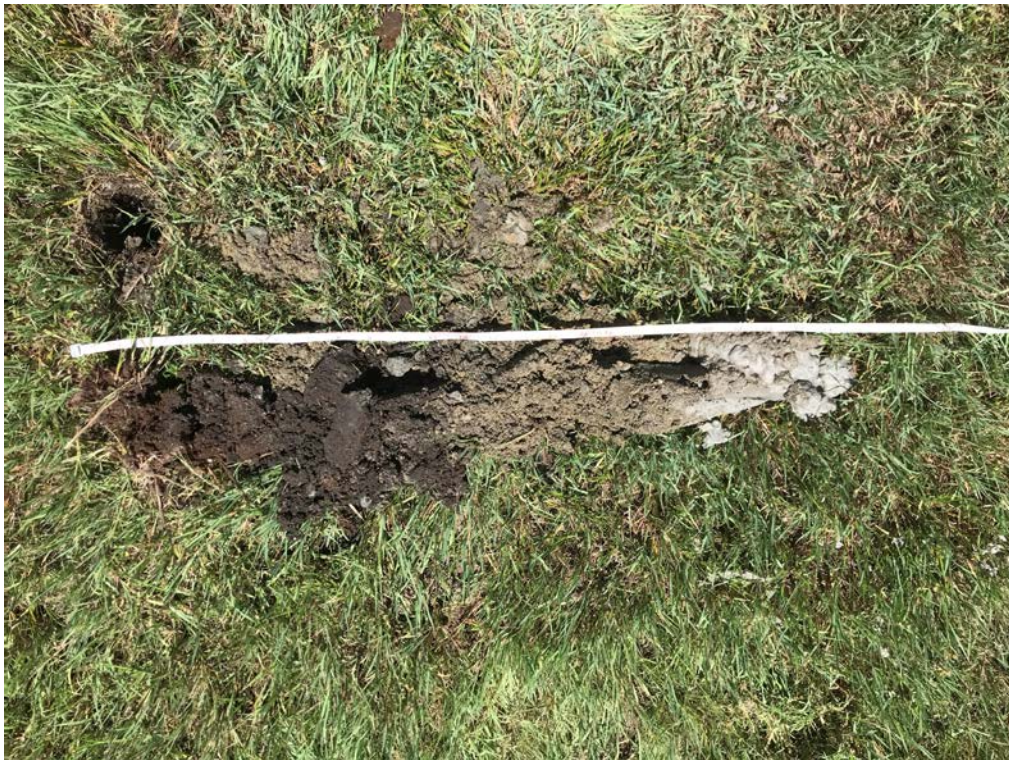
Photo 12: View of soil profile from augured observation pit #4. This pit was located along the north central perimeter of the field. Hydric soil indicators were observed within 12" of the soil surface and the water table was measured at 16" below the soil surface.

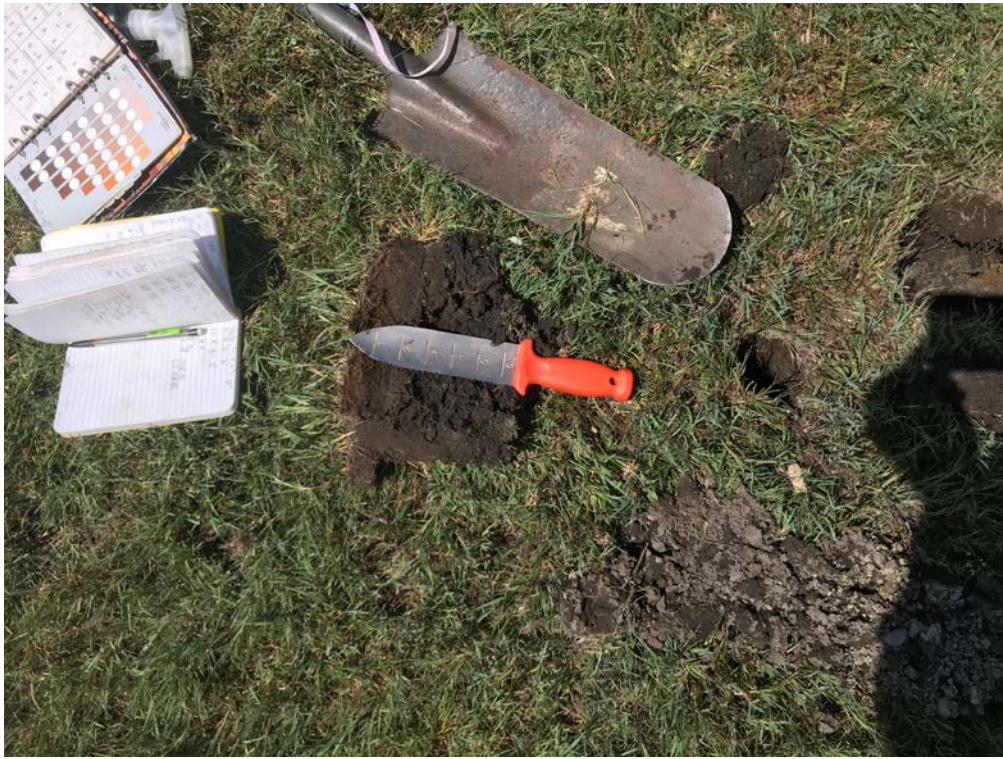
Photo 13: View of A-horizon from soil observation pit #7 located in the east central portion of the field.

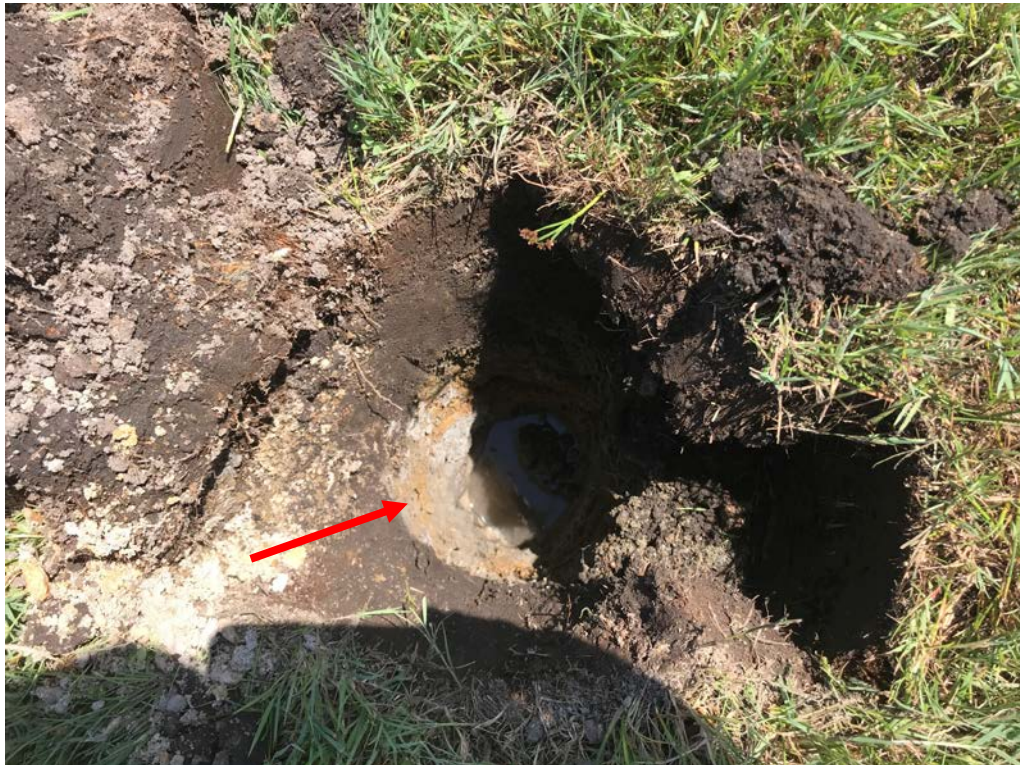
Photo 14: Soil observation pit #7. Standing water was observed at 16" below the soil surface at this location. Hydric soil indicators were present within the upper 12" of mineral soil.

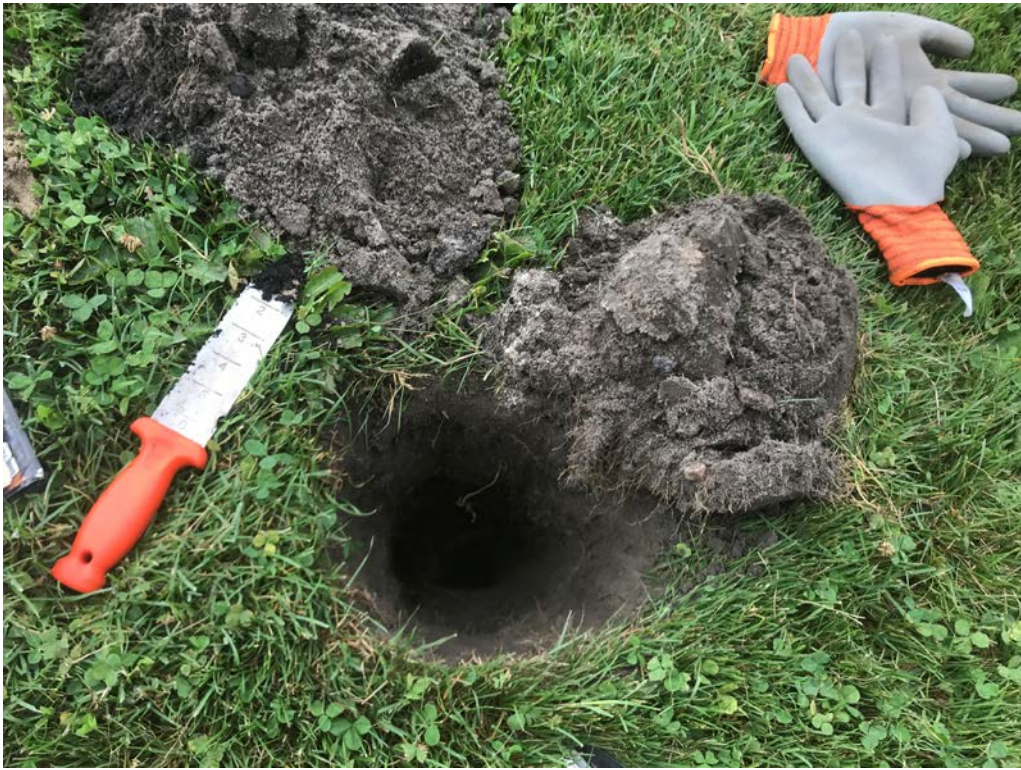
Photo 15: View of upland soil observation plot located along eastern slope above Castine Field.

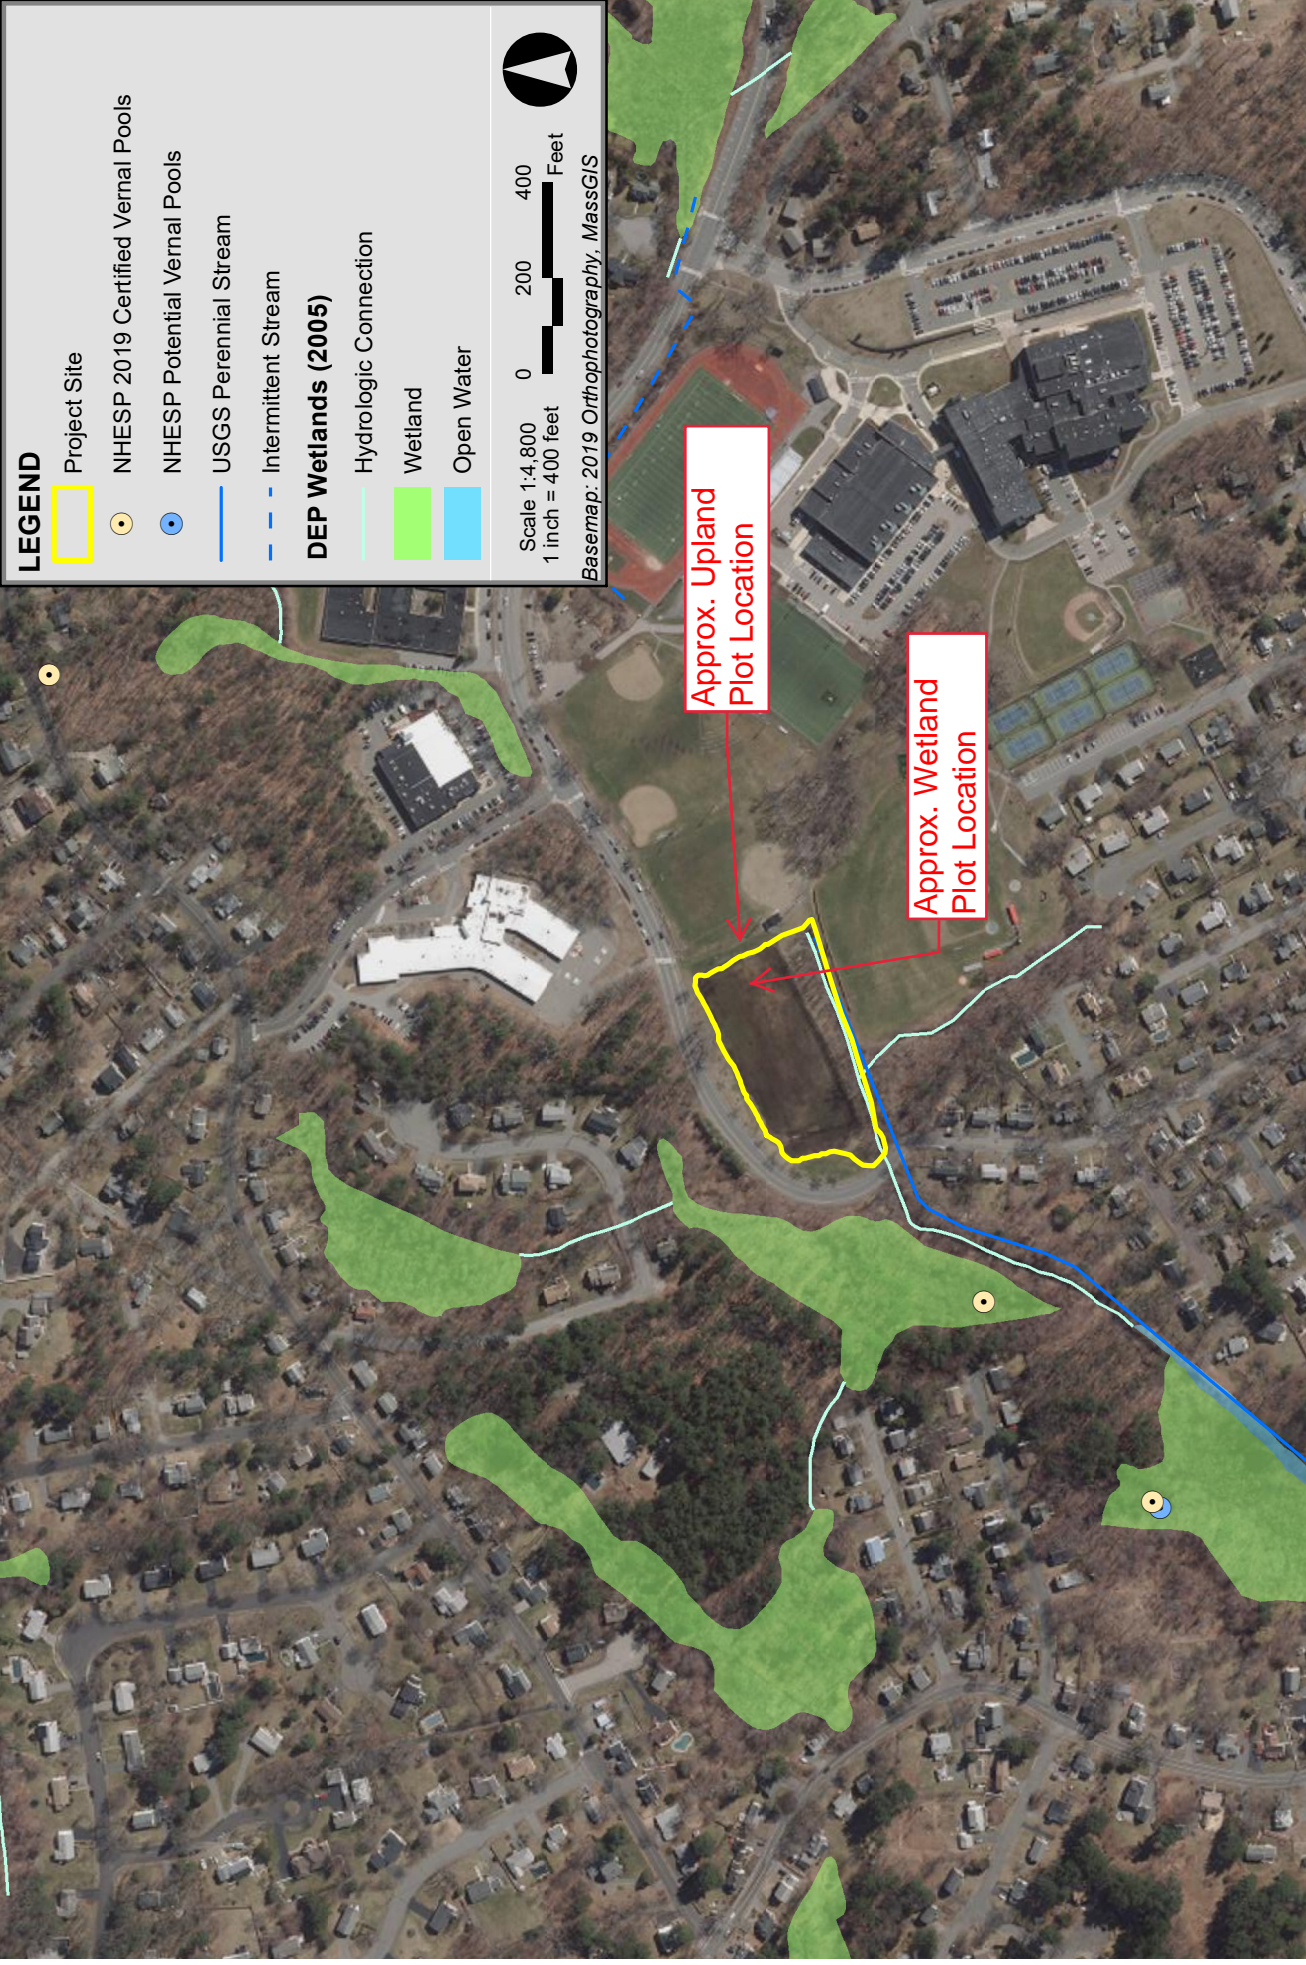
Castine Field – Birch Meadow Park Reading, MA
